SPECIAL WEAPONS AND TACTICS
(SWAT) POLICE STATION
HILLA, IRAQ

SIGIR PA-05-018
JANUARY 30, 2006

SUBJECT: Report on Project Assessment of the Special Weapons and Tactics (SWAT)
Police Station in Hilla, Iraq (Report Number SIGIR-PA-05-018)

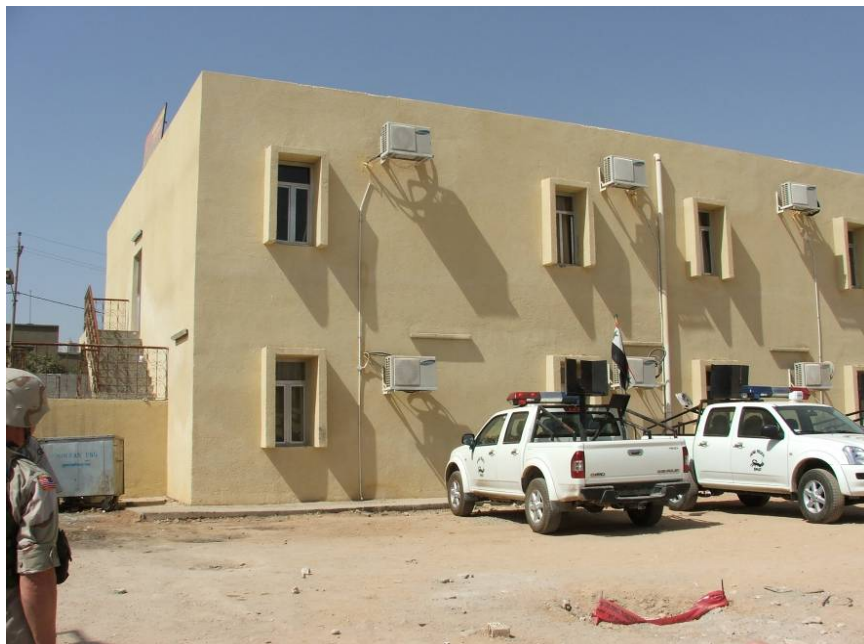
Site Photo 1. Exterior Front of Two-Story Sleeping Quarters Building

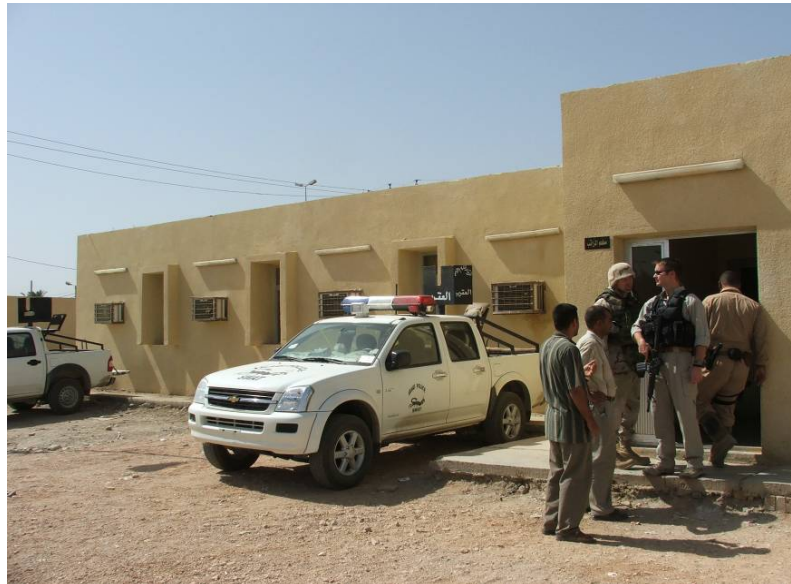
Site Photo 5. Exterior View of Dining Facility

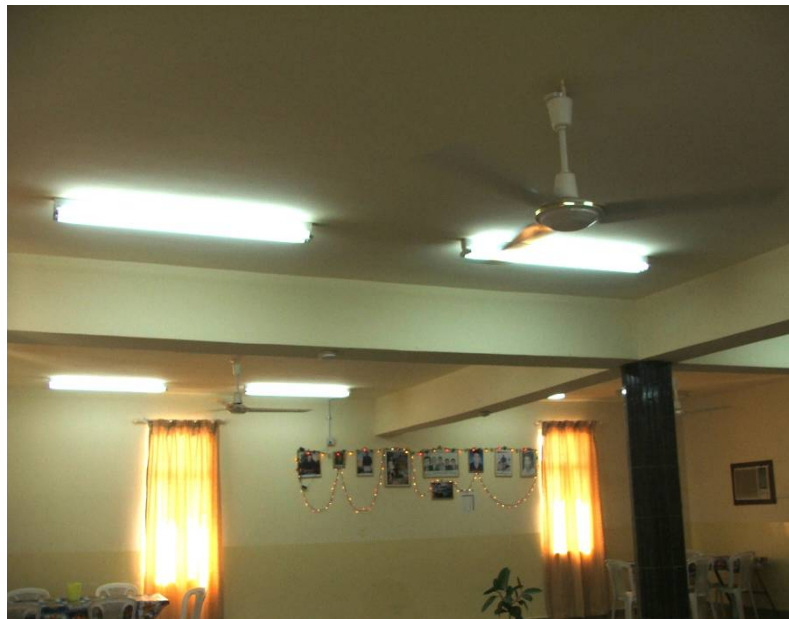
The contract and design required the construction of a one-story facility with reinforced concrete footings, reinforced concrete slab, reinforced concrete columns and beams, and stucco over block exterior. The building design required a 16.93 M (55.5 ft) by 16.61 M (54.5 ft) facility. The building included one large area for dining, one room for food preparation, two rooms for storage, and a common lavatory. The contract required the facility to include A/C units. During the site visit, we verified the building was constructed and used as a dining facility. For an illustration of the exterior front of the dining facility, see Site Photo 5. For an illustration of the dining facility's interior dining room, see Site Photo 6. We observed A/C, lights, and fans to be operational.

Site Photo 6. Interior of Dining Area

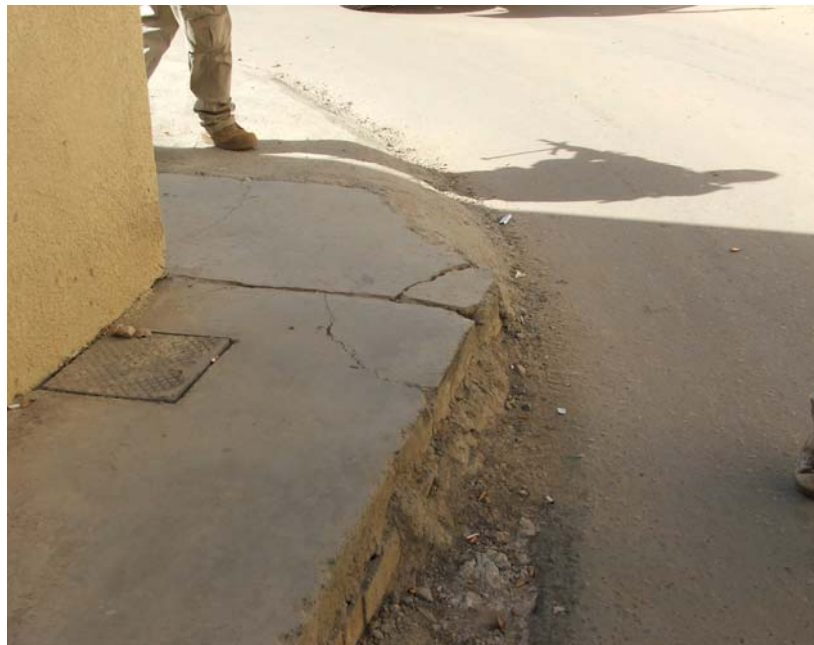
The contract and design required the construction of a one-story facility with reinforced concrete footings, reinforced concrete slab, reinforced concrete columns and beams, and stucco over block exterior. The building design required a 4.75 M (15.6 ft) by 12.25 M (40.2 ft) facility consisting of a small office, lavatory, and three-open vehicle bays. During the site visit, we verified the building was constructed. For an illustration of the exterior of the Vehicle Affairs building, see Site Photo 14. During the site visit, we noted that the concrete sidewalk adjacent to the Vehicles Affairs building was cracked. For an illustration of the cracks in the sidewalk at the Vehicle Affairs building, see Site Photo 15.

Site Photo 15. Sidewalk of Vehicle Affairs Building

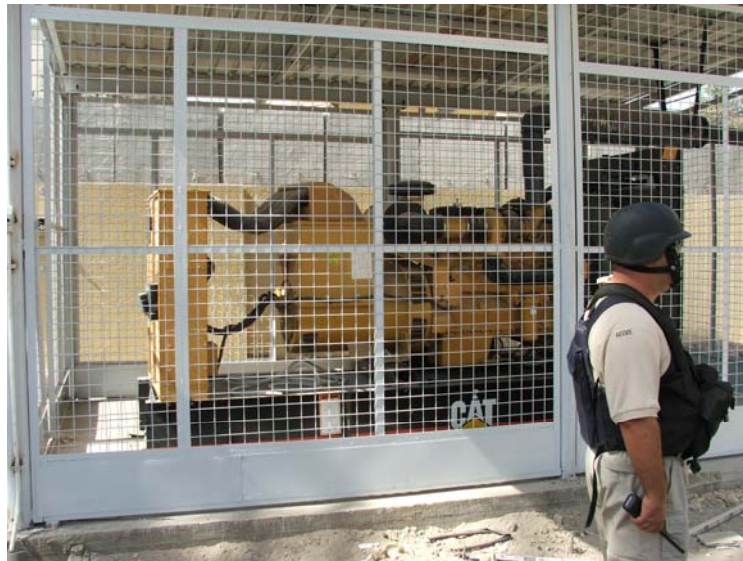
Site Photo 17. Generator Unit with Mesh Enclosure

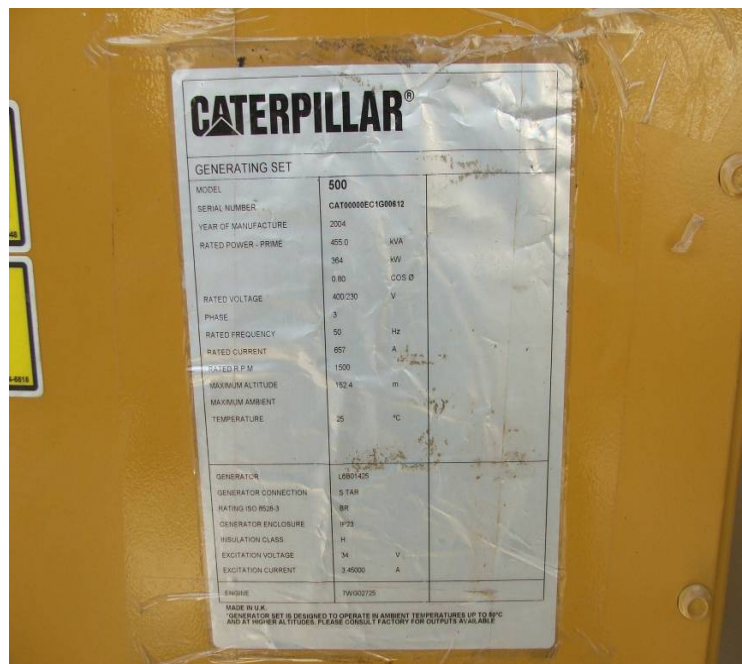
The engine block factory nameplate showed the Engine Serial Number as 7WG02725, although the engine block serial number was partially painted over. For illustrations of the paper copy of the generator nameplate and the engine block factory nameplate, see Site Photos 18 and 19, respectively.

Site Photo 18. Paper Copy of Factory Nameplate

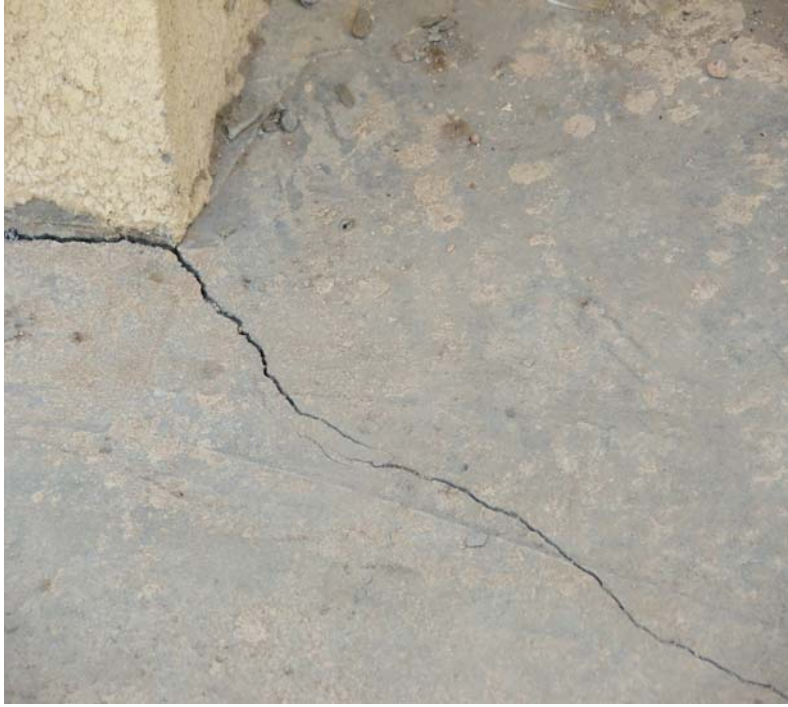
The contract's SOW required the renovation of the remaining buildings after the demolition of the damaged buildings. The SOW stated, "the second phase is the renovation of remaining buildings to temporarily house SWAT personnel as described in the attached Bill of Materials (BOM)." A complete assessment of the renovation of the existing facilities was not completed, although we conducted a walk through of the renovated buildings. Observations of cracks in the new side walks, cracks in the stucco exterior of the building, improperly installed stairwell railings (similar installation to the sleeping quarter and operations room facility), and cracks in the interior security walls are signs of poor workmanship during the rehabilitation of the facilities. For illustrations of the cracks in the front of renovated building #2 and in the interior security walls behind the Vehicle Affairs building, see Site

Site Photo 20. Cracks in Concrete Sidewalks of Renovated Building #2

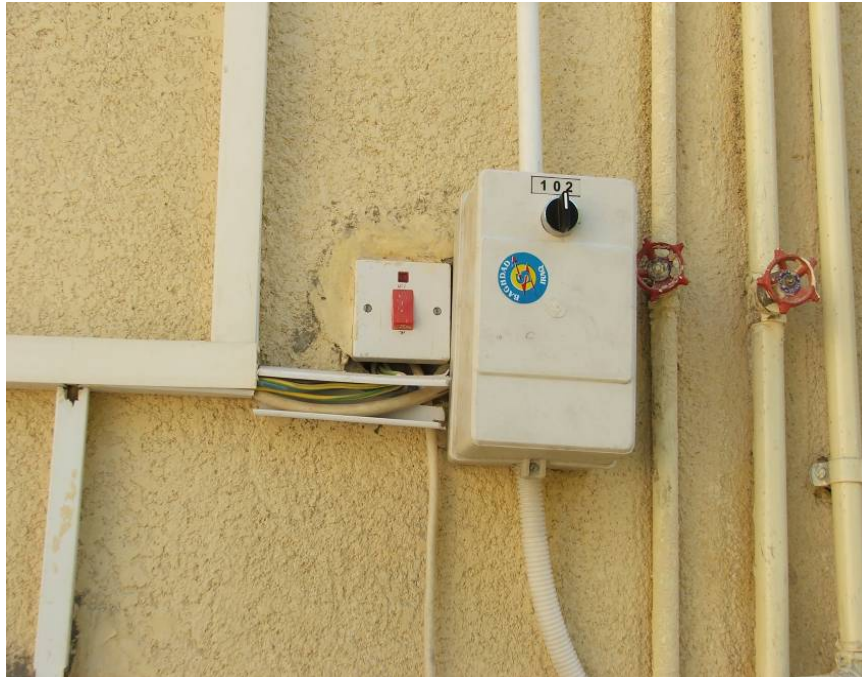
Photos 20 and 21, respectively. Site Photo 22 illustrates exposed electrical wires located in the exterior of renovated building 10.

Site Photo 22. Renovated Building 10, Exterior Electrical Switches
